Nantucket Land Council, Inc.

March 14, 2014

Re: Geotube Construction - Baxter Road, Nantucket

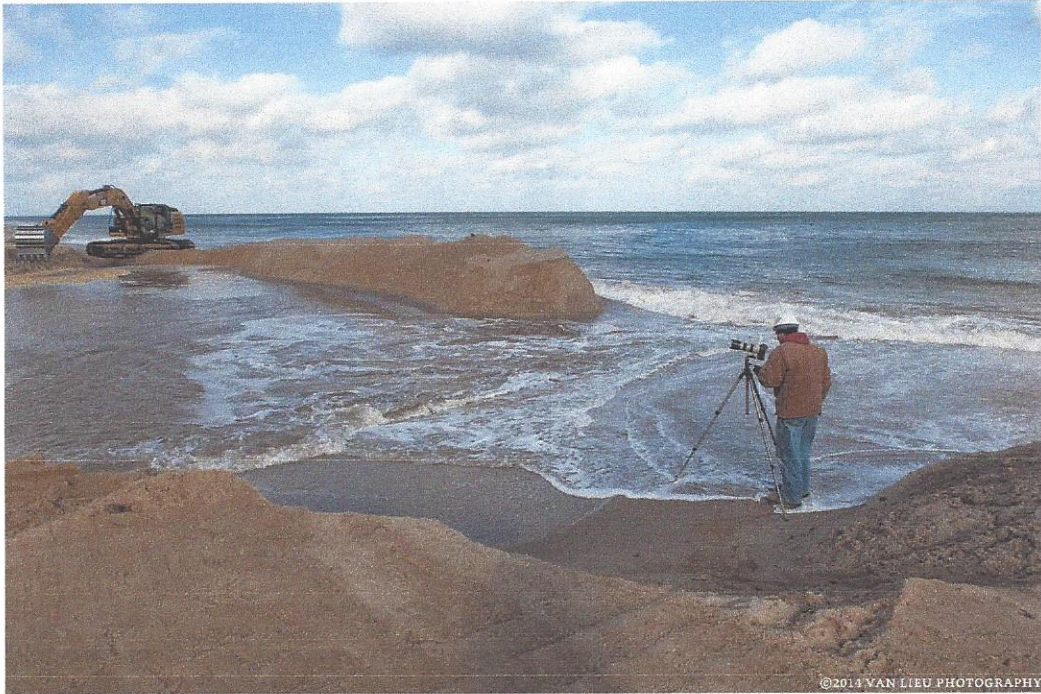
Figure 1: A photograph illustrating the use of an excavated trench in the beach seaward of the geotube revetment with material excavated from the trench piled into a berm. The end of the trench has been excavated through the beach into the Atlantic Ocean allowing the fluidize pump to be completely submerged. Note the calm ocean waters and resulting lack of wave setup and runup.

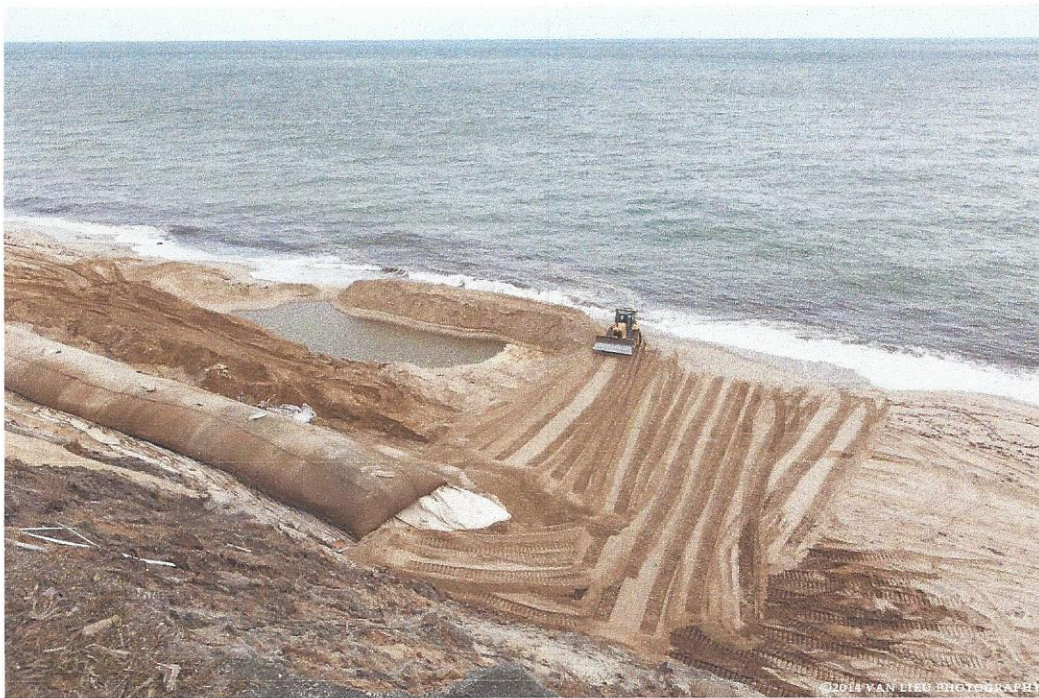
Figure 2: A bulldozer grading the beach after the second geotube was filled. The trench in the beach face is still evident with the inlet to the trench from the Atlantic Ocean. The inlet has almost completely shoaled in due to wave action.

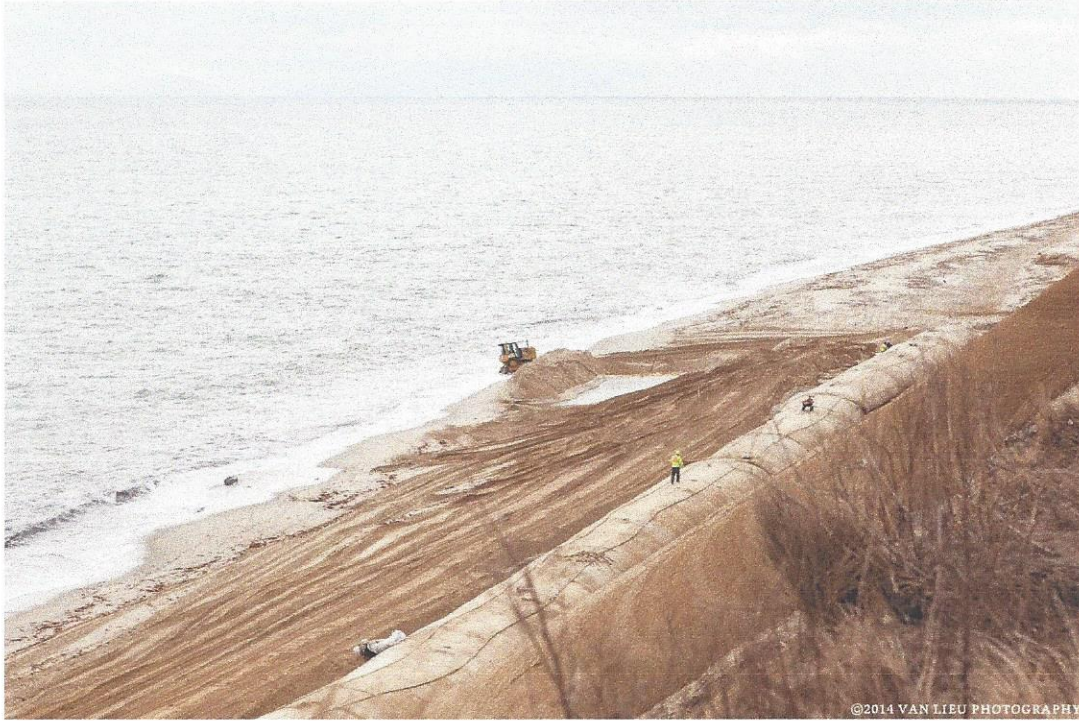
Figure 3: A bulldozer grading the remnants of a fluidizing trench and berm on Sconset Beach, the berm and bulldozer are clearly seaward of the mean high water line.

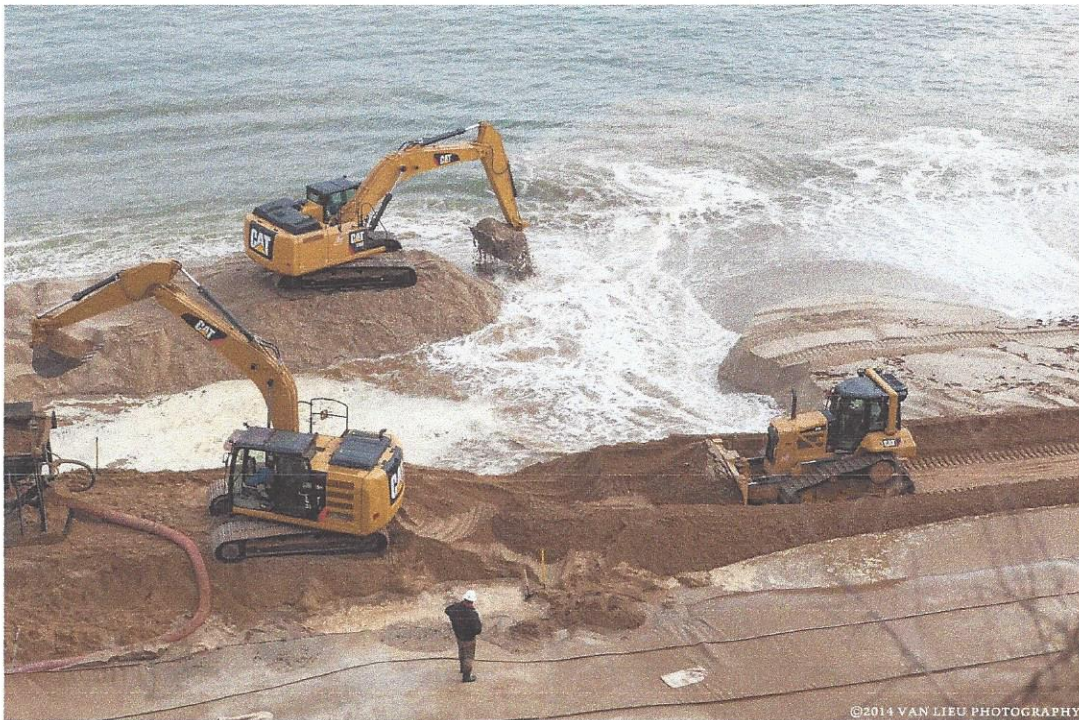
Figure 4: An excavator removing its bucket full of sediment from the Atlantic Ocean. The beach on the right side of the photograph clearly illustrates that the construction activities are occurring seaward of the MHW line. Note the calm ocean waters and resulting lack of wave setup and runup.

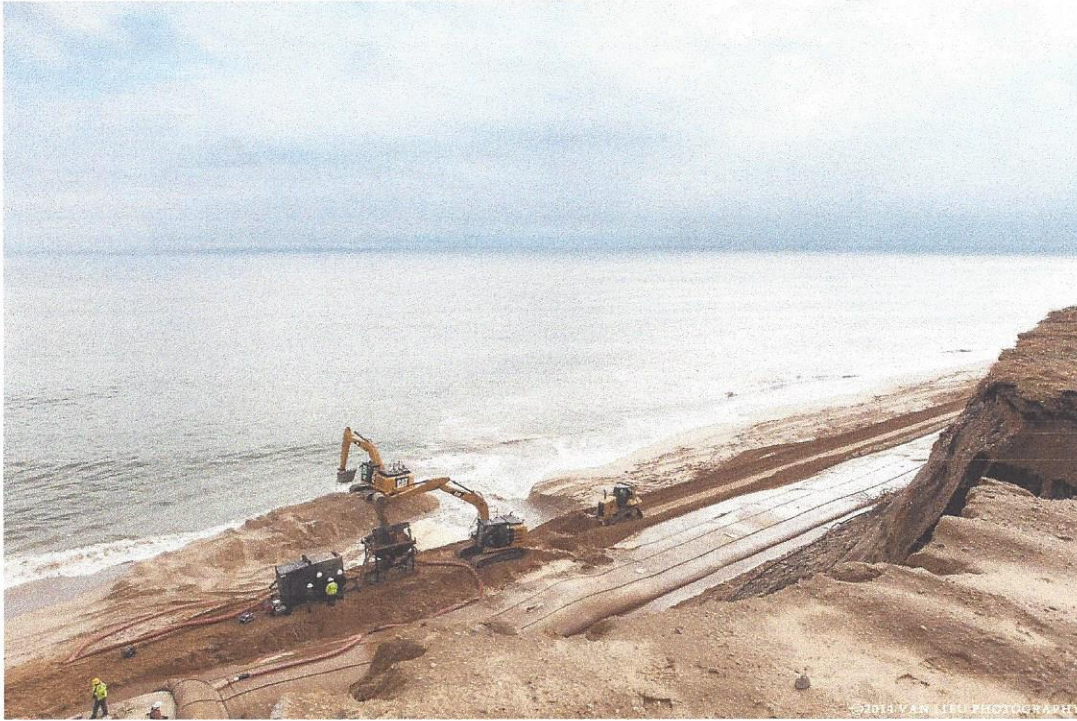
Figure 5: Note the calm ocean waters and resulting lack of wave setup and runup with an excavator sitting on a sand berm constructed seaward of the MHW line while excavating material from the ocean bottom.

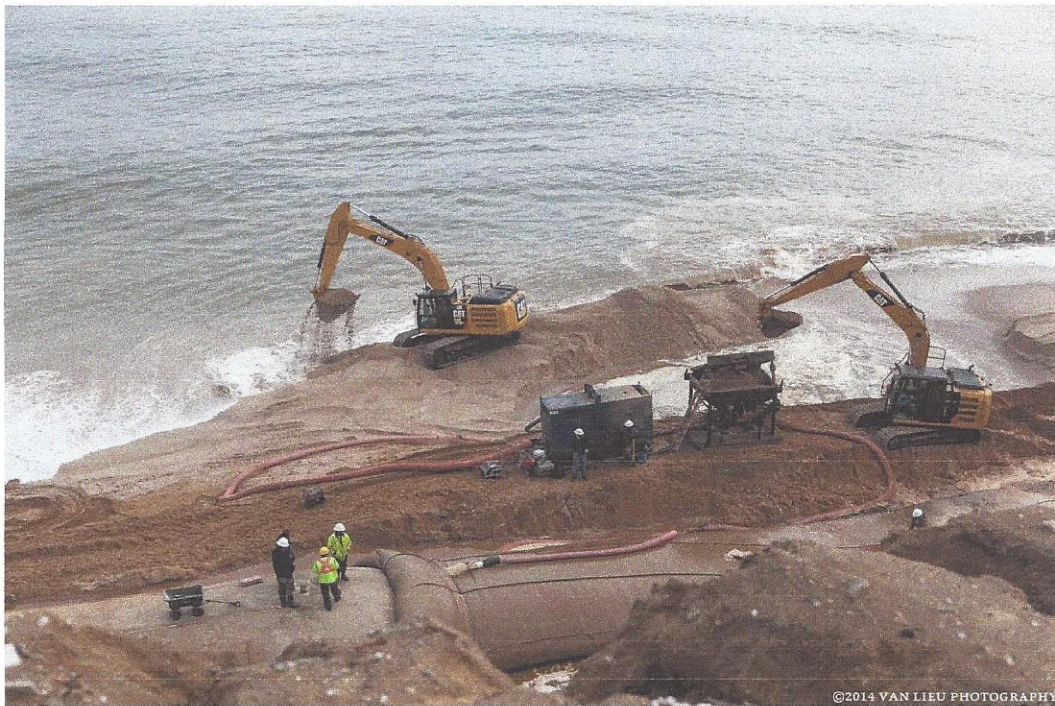
Figure 6: An excavator sitting seaward of the MHW line stabilizing the sand berm which is used to protect the trench from which saltwater is continuously drawn at all phases of the tide to fill the geotubes. Note that the pump intake is completely submerged.

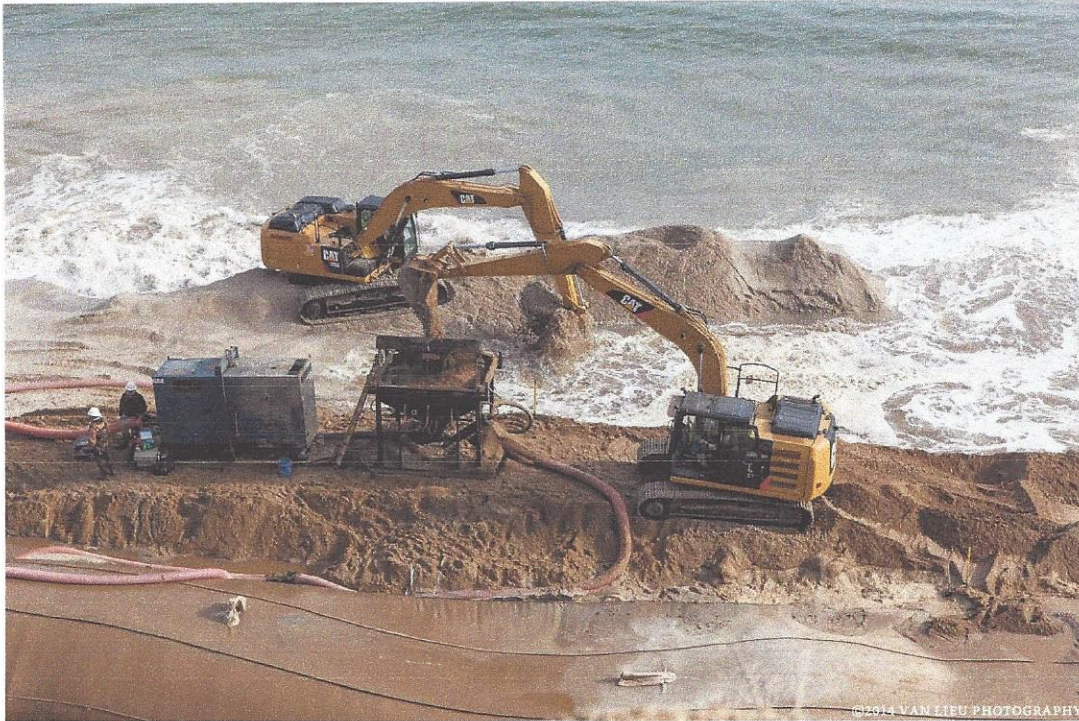
Figure 7: An excavator dredging material from below the ocean surface clearly seaward of the MHW line. Note the lack of significant wave uprush within the surf zone.

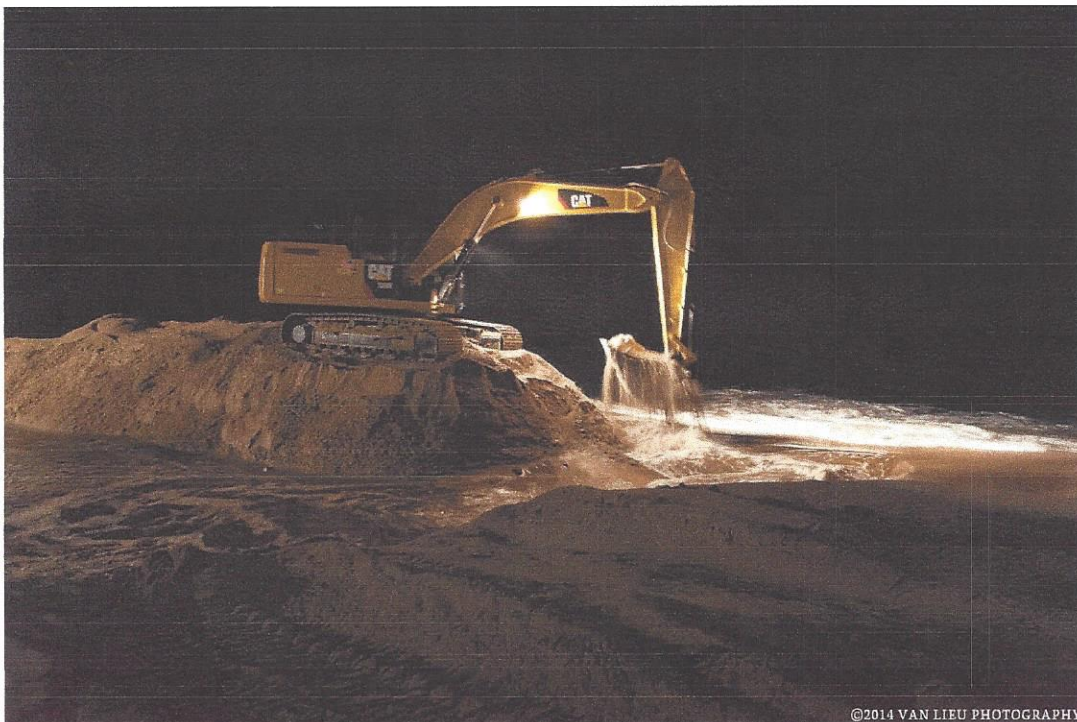
Figure 8: An excavator dredging material from below the ocean surface at night. This illustrates that construction activities were occurring at all phases of the tide and manipulations of the MHW line clearly resulting in dredging and filling seaward of the MHW line.

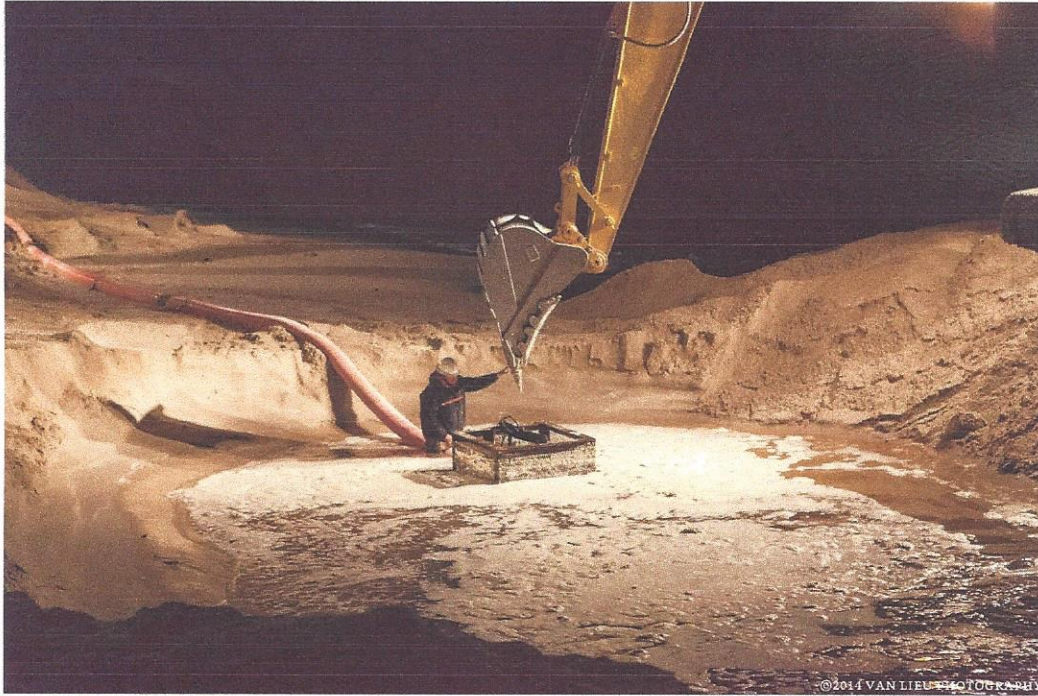
Figure 9: An excavator adjusting the position of the saltwater intake for the fluidizing pump. Note the size of the intake relative to the individual in the water. The size of the intake requires at a minimum an excavation of 3 to 4 feet below the surface of the ocean to keep the intake submerged under all phases of the tide.

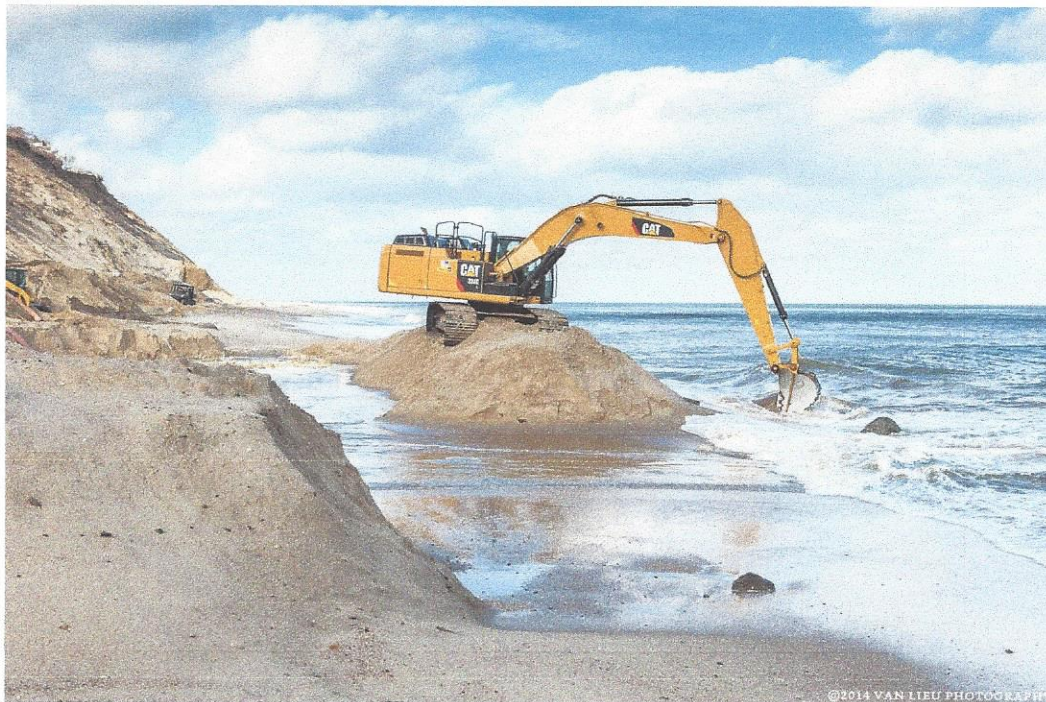
Figure 10: An excavator dredging material from below the ocean surface. Could DEP provide clarification on the position of the MHW in this photograph? Note the calm ocean waters and resulting lack of wave setup and runup.

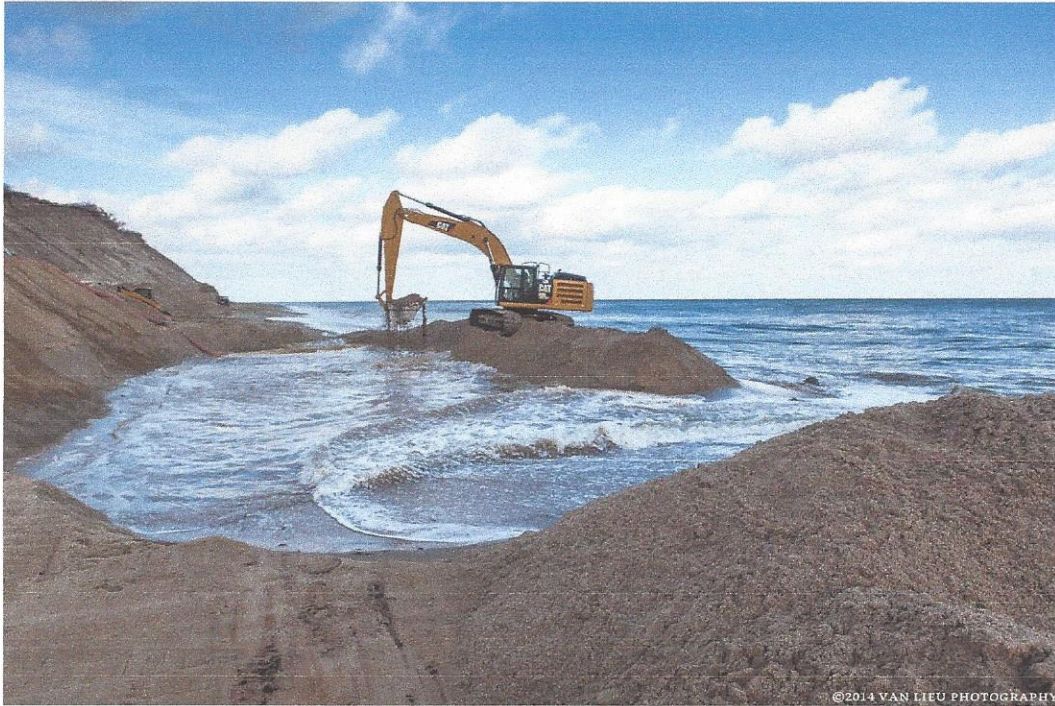
Figure 11: An excavator dredging material from atop the berm constructed seaward of the trench used to supply saltwater to the fluidize pump. A clear illustration of the contractor operating seaward of the MHW line.
